**Flood Control Project Maintenance
Levee Inspections**

Fall 2018 Levee Maintenance Deficiency Summary Report

Sacramento River Basin

City of Sacramento

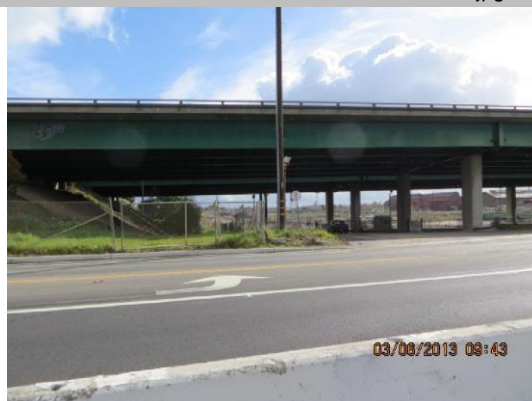
Photo 1 of 3 : UCIP_FA_2018_49955_33806.jpg

View of levee crown at crossing--sign visible on landward side near freeway underpass.

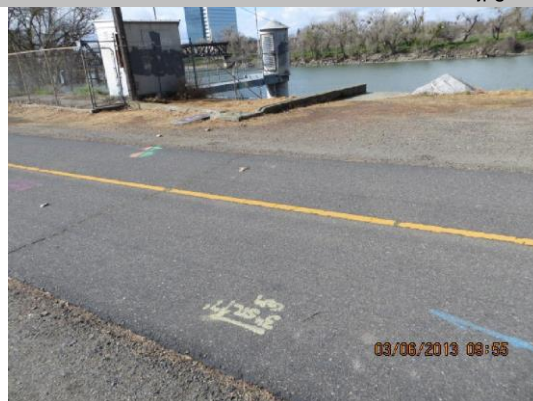
Photo 1 of 3 : UCIP_FA_2018_41414_72622.jpg

View of levee crown and waterward side.

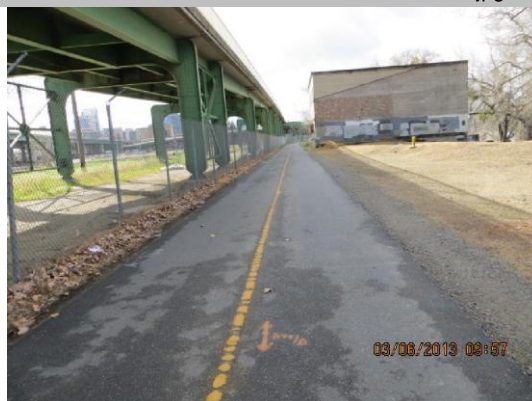
Photo 1 of 2 : UCIP_FA_2018_41416_72629.jpg

Alignment of communication line through levee, Photo 1 of 2.

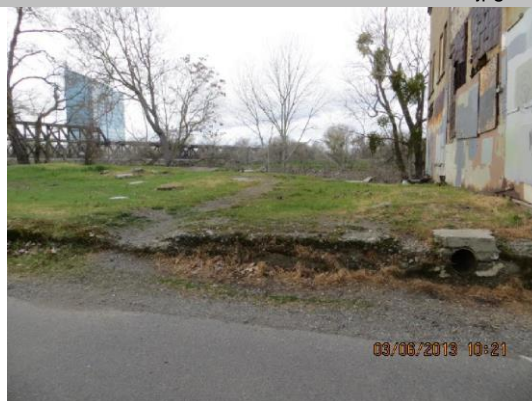
Photo 2 of 3 : UCIP_FA_2018_40848_72632.jpg

View of levee crown at crossing.

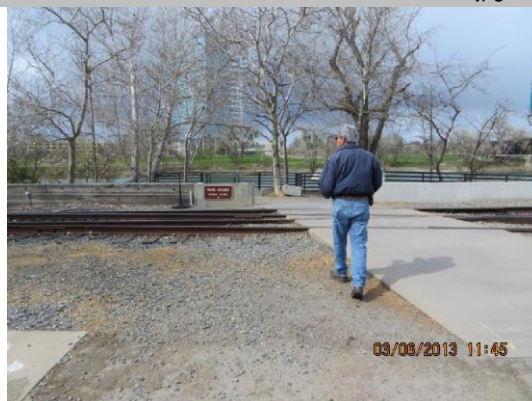
Photo 1 of 3 : UCIP_FA_2018_20384_34410.jpg

View of levee crown downtown Sacramento--wide crown with railroad.

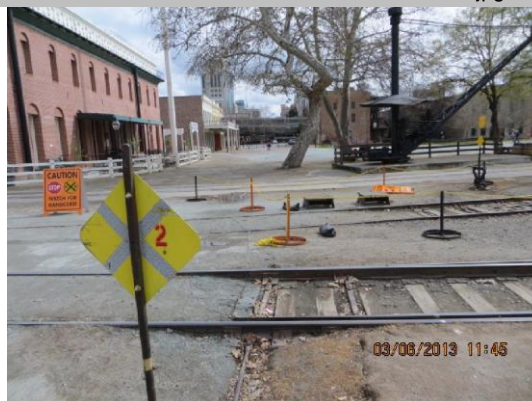
Photo 3 of 3 : UCIP_FA_2018_20384_34408.jpg

View of landward side close to railroad museum.

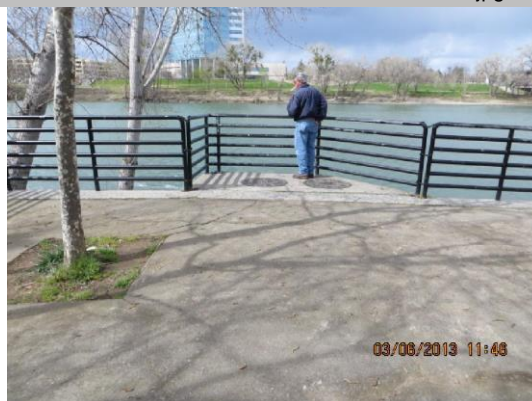
Photo 2 of 3 : UCIP_FA_2018_41417_72641.jpg

Manholes located along levee--waterward side.

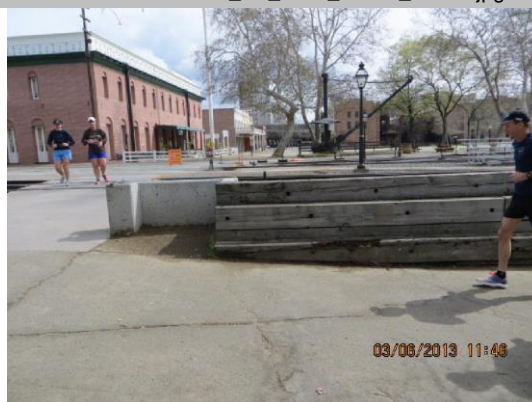
Photo 3 of 3 : UCIP_FA_2018_41417_72640.jpg

View of landward side.

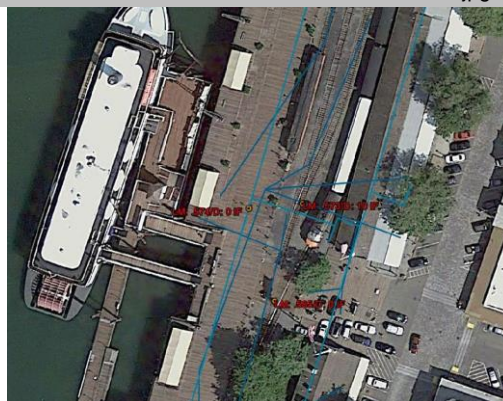
Photo 1 of 1 : UCIP_FA_2018_41419_72742.jpg

Comment Code						
Inspector Comment						
FS_ID:41419 DS_ID:24895 EP_NO: N/A Repair Type: Non-Urgent Crossing Status: Indicator Found UCIP Comments: 06/06/2017 Received documentation from the City of Sacramento indicating that this crossing was internally inspected on 10/28/2013, PACP Sewer Report was provided. PACP report is missing rating evaluation. No additional information was received from the City of Sacramento. Need to request evaluation of pipe (integrity of pipe section through the levee) and find out when the City is planning the next internal inspection for this pipe. (DWR UCIP – O. Magana) 03/06/2013 Need to confirm if crossing is still present. No signs visible during site visit. No photos available. FIELD_STRUCT_DESC: 10-inch vitrified clay drainage pipe through levee at an unknown depth. Record was obtained from the City of Sacramento's kml file with approximate utility alignment. FS Date: 3/6/2013

Approximate alignment provided by the City of Sacramento--unable to confirm crossing in field.

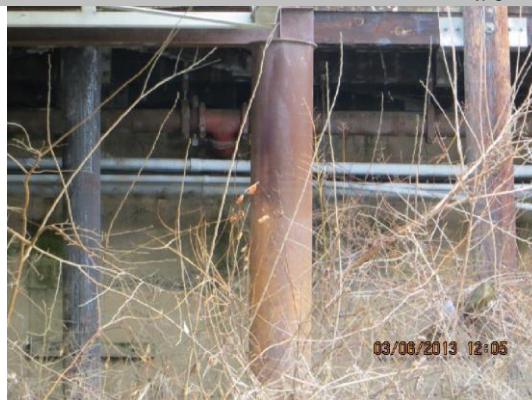
Photo 1 of 1 : UCIP_FA_2018_41438_72745.jpg

LM Start	0.61	Rating **	M	Issue No.	105
LM End	0.61	Issue Type +	En	Location *	
Category	Supplemental			GPS Latitude/Longitude	
				Start	End
Item	DWR UCIP Field Study			38.582167°	38.582167°
				-121.506537°	-121.506537°
DWR ID	24898				
Comment Code					
Inspector Comment					
FS_ID:41438					
DS_ID:24898					
EP_NO: N/A					
Repair Type: Non-Urgent					
Crossing Status: Indicator Found					
UCIP Comments: Unable to determine if crossing is active--need to contact owner to determine status and additional details of crossing.					
FIELD_STRUCT_DESC: Sewer line through levee.					
FS Date: 3/6/2013

View of crossing visible from waterward side looking at floodwall.

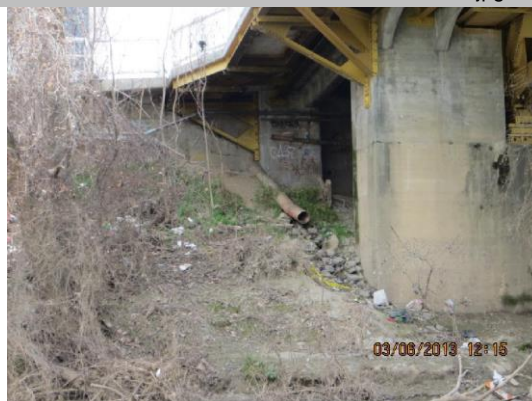
Photo 1 of 3 : UCIP_FA_2018_41421_72750.jpg

Comment Code						
Inspector Comment						
FS_ID:41421 DS_ID:24905 EP_NO: N/A Repair Type: Non-Urgent Crossing Status: Indicator Found UCIP Comments: 07/21/2016 Meet with City of Sacramento North Area Drainage representatives: Mick Smith and Mike Gonsalves. This crossing appears to be a Caltrans pipe and is part of the permit for the Bridge. Pipe might not go through levee. Need to pull Bridge permit to review As-built drawings. (DWR UCIP – O. Magana) 03/06/2013 Need to contact owner to determine status and permit number for crossing. (DWR UCIP - O. Magana) FIELD_STRUCT_DESC: Corrugated metal drainage pipe through floodwall visible on waterside (WS). FS Date: 3/6/2013

View of waterward side.

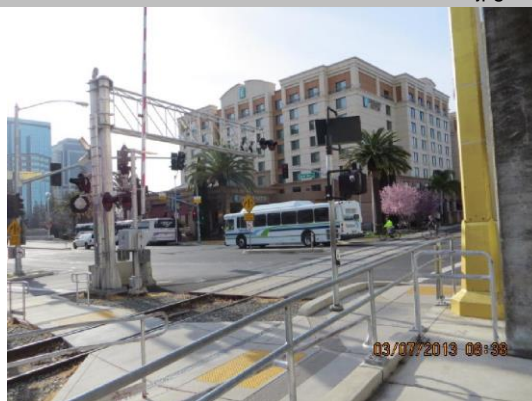
Photo 3 of 3 : UCIP_FA_2018_41421_72748.jpg

View of general area immediately downstream from crossing.

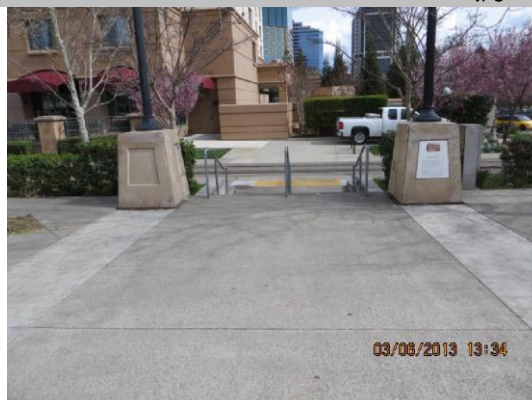
Photo 3 of 3 : UCIP_FA_2018_41422_72752.jpg

View of landward side.

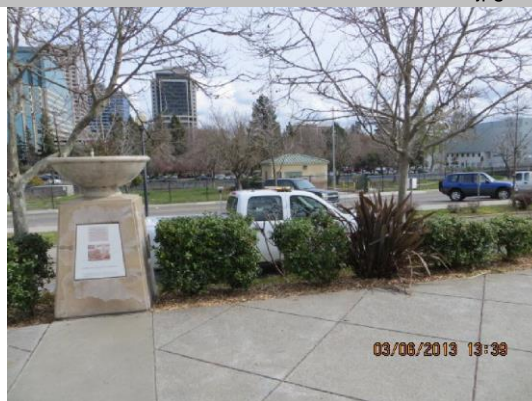
Photo 1 of 3 : UCIP_FA_2018_52601_34414.jpg

07/21/2016 Meet with City of Sacramento North Area Drainage representatives: Mick Smith and Mike Gonsalves. Mike Gonsalves mentioned that inspection completed in 2016 by Caltrans revealed structure needed some repairs. Caltrans is working at replacing/repairing pipe by 2018. (DWR UCIP – O. Magana)
FIELD_STRUCT_DESC: [O Street Outfall] 30-inch concrete encased drainage pipe through the levee, 6.2 feet below the crown. Gate valves and siphon breaker in concrete box in the waterside (WS) shoulder. Concrete headwall on the WS. Pump on the landside (LS). Ramp on LS "O" Street. (30-inch pipe authorized under Permit No. 5695-A, 1970 - State of California, Department of Public Works Division of Highways [Caltrans]) [Additional Reference(s): DWR Levee Log, 1993]
FS Date: 3/6/2013

View of landward side--wide levee crown.

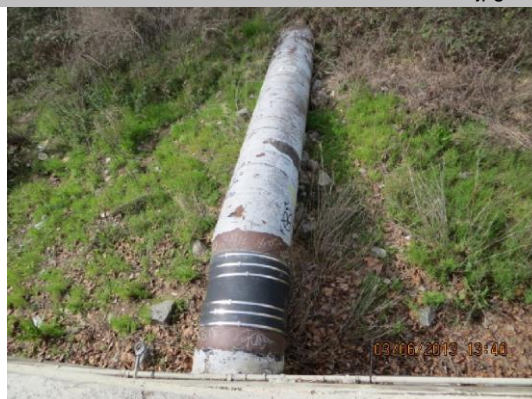
Photo 3 of 3 : UCIP_FA_2018_52601_34412.jpg

View of pipe crossing through floodwall--waterward side.

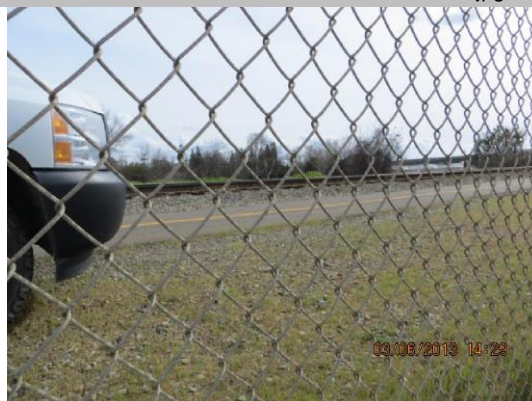
Photo 1 of 3 : UCIP_FA_2018_41425_34145.jpg

Item	DWR UCIP Field Study		38.573901 °	38.573901 °								
			-121.511025 °	-121.511025 °								
DWR ID	21565											
Comment Code												
Inspector Comment												
FS_ID:41425 DS_ID:21565 EP_NO: 5140 Repair Type: Non-Urgent Crossing Status: Indicator Found UCIP Comments: 07/21/2016 Meet with City of Sacramento North Area Drainage representatives: Mick Smith and Mike Gonsalves. Pipe was abandoned in February 2016. Pipe was slurry filled, cut on the LS, and capped. Pipe was abandoned, see Permit No. 5140 records, as part of the Central Plant Renovation Project #113072 Outfall and Pipeline Abandonment at the Ranney Well Site Letter of Authorization (2015). (DWR UCIP – O. Magana) 03/06/2013 Need to determine more details pertaining to crossing, coordinate with City of Sacramento. Is crossing active? (DWR UCIP - O. Magana) FIELD_STRUCT_DESC: *ABANDONED* 30-inch reinforced concrete condensing water pipe sleeved through 40-inch diameter pipe through the levee, 5 feet below the levee crown. Annular space between 30-inch pipe and 40-inch pipe grouted. Anchor blocks on both ends, concrete pipes under pads over pipe under railroad. Cap on the waterside (WS) end. A 1.5-foot thick by 8-foot high by 8-foot wide reinforced concrete headwall supported on a 2-foot thick by 5.5-foot wide by 12-foot long concrete footing. An 8-foot high by 64-foot wide apron constructed around the waterside (WS) end of the pipe at the WS shoulder of the levee. 18-inch temporary diameter welded steel pipe sleeved through existing 30 inch used to convey water from construction site. (30-inch pipe authorized under Permit No. 5140, 1966 - State of California- Department of General Services, abandonment of 30-inch pipe request as part of the Central Plant Renovation Project #113072 Outfall and Pipeline Abandonment at the Ranney Well Site Letter of Authorization (2015); 18-inch pipe sleeved through existing 30-inch pipe authorized under Permit No. 5745, 1967 - Ranney Method Western Corporation) [Additional Reference(s): DWR Levee Log, 1993] FS Date: 3/6/2013

View of railroad and bike path located on levee crown--wide levee.

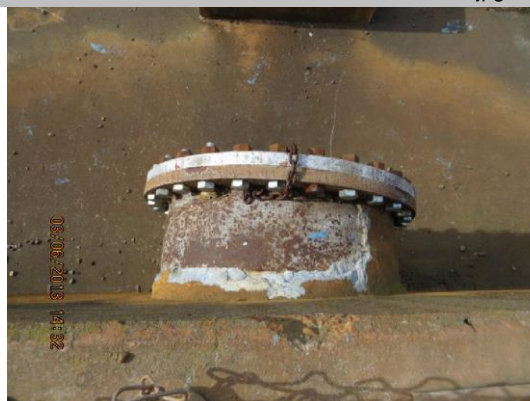
Photo 3 of 3 : UCIP_FA_2018_41425_34143.jpg

Metal plate used to cap off pipe.

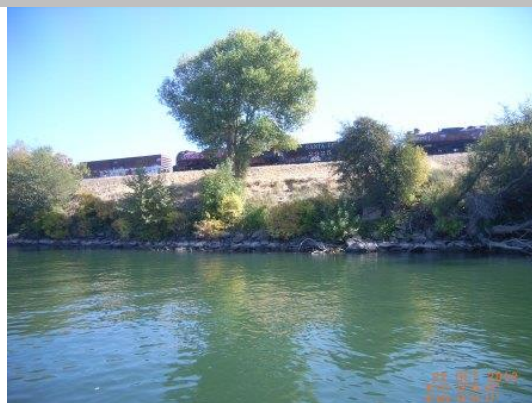
Photo 1 of 2 : FA_2018_NA0005_251_72_20181023_00116.jpg

LM Start	1.31	Rating **	M	Issue No.	72
LM End	1.39	Issue Type +	Ma	Location *	WS
Category	Supplemental			GPS Latitude/Longitude	
				Start	End
Item	2017 USACE Erosion Survey, DRAFT			38.573169 °	38.572277 °
				-121.511998 °	-121.513063 °
DWR ID	DWR_NA0005_01_f _ 2018_72				
Comment Code					
Inspector Comment					
2017 Site ID: SAC 58.5 L					
Status: Eroding					
2017 Field Notes: Slump sections along mid bank. City requested PL 84-99 assistance.					
Site History: 2008 - Oversized levee, should be repaired under maintenance. 2009 - Shallow slumps at the mid bank. 2010 - Some minor erosion at the toe, likely from wave wash. Some new shallow slumps. 2011 - One new tree has fallen. 2013 - Erosion continues on the slope surface, site extended upstream.

USACE 2013 Photo #1

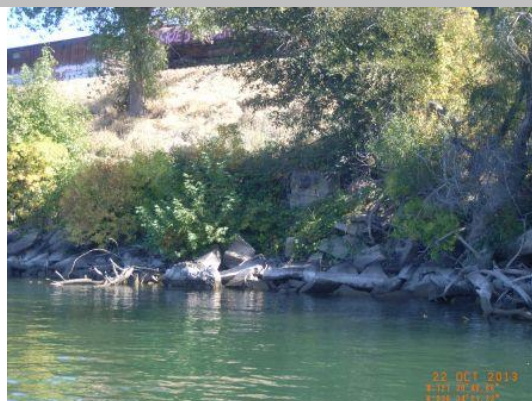
Photo 2 of 2 : FA_2018_NA0005_251_72_20181023_00117.jpg

LM Start	1.31	Rating **	M	Issue No.	72 (cont)	
LM End	1.39	Issue Type +	Ma	Location *	WS	
Category	Supplemental			GPS Latitude/Longitude		
				Start	End	
Item	2017 USACE Erosion Survey, DRAFT			38.573169 °	38.572277 °	
				-121.511998 °	-121.513063 °	
DWR ID	DWR_NA0005_01_f_2018_72					
Comment Code						
Inspector Comment						
2017 Site ID: SAC 58.5 L						
Status: Eroding						
2017 Field Notes: Slump sections along mid bank. City requested PL 84-99 assistance.						
Site History: 2008 - Oversized levee, should be repaired under maintenance. 2009 - Shallow slumps at the mid bank. 2010 - Some minor erosion at the toe, likely from wave wash. Some new shallow slumps. 2011 - One new tree has fallen. 2013 - Erosion continues on the slope surface, site extended upstream.

USACE 2013 Photo #2

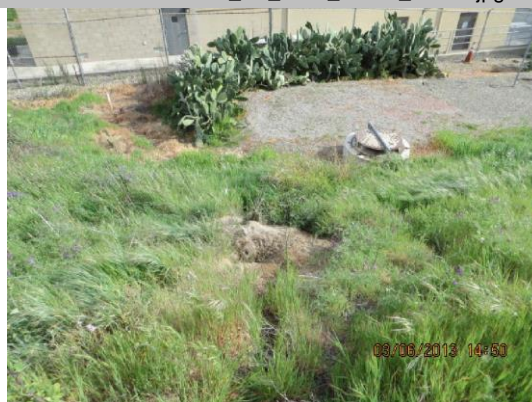
Photo 1 of 2 : UCIP_FA_2018_49767_34067.jpg

Comment Code						
Inspector Comment						
FS_ID:49767 DS_ID:21580 EP_NO: N/A Repair Type: Non-Urgent Crossing Status: Found UCIP Comments: 07/21/2016 Meet with City of Sacramento North Area Drainage representatives: Mick Smith and Mike Gonsalves. No Additional information was made available regarding the fate of this crossing. (DWR UCIP – O. Magana) 03/06/2013 Dense vegetation limits the inspector's visibility to identify signs of pipe failure (leaks) along the waterward and landward slope. Recommend removing vegetation along pipe alignment to conduct proper inspection of structure and appurtenances. (DWR UCIP - O. Magana) FIELD_STRUCT_DESC: [SUMP 1] 1 of 3: 6-inch steel water line through the levee, 8 feet below the crown. Gate valves located on the waterside (WS) slope. Manhole located on landside (LS) berm. [Additional Reference(s): DWR Levee Log, 1993] FS Date: 3/6/2013

View of landward side where crossing should be running through.

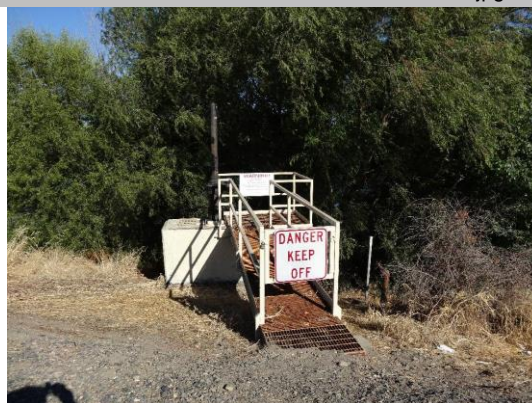
Photo 3 of 3 : UCIP_FA_2018_49957_75769.jpg

FIELD_STRUCT_DESC: [SUMP 1] 2 of 3: 60-inch concrete sewer line through the levee at low elevation. Slide gate inside concrete well located on the waterside (WS) slope. Manhole located on landside (LS) berm. Discharge gate located on the WS. Multiple manholes are located on LS berm. [Additional Reference(s): DWR Levee Log, 1993]
FS Date: 7/19/2016

View of WS--gate inside concrete structure.

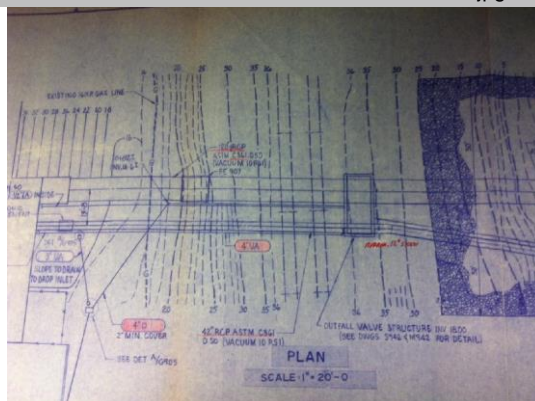
Photo 1 of 3 : UCIP_FA_2018_49778_34024.jpg

DWG showing 42-inch and 120-inch pipes through levee and connection to outfall valve structure.

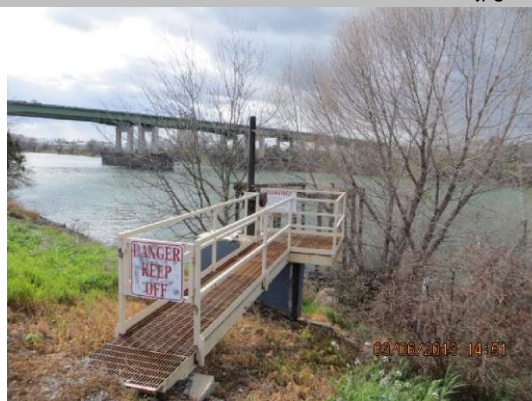
Photo 3 of 3 : UCIP_FA_2018_49778_34025.jpg

Walkway present on waterward shoulder.

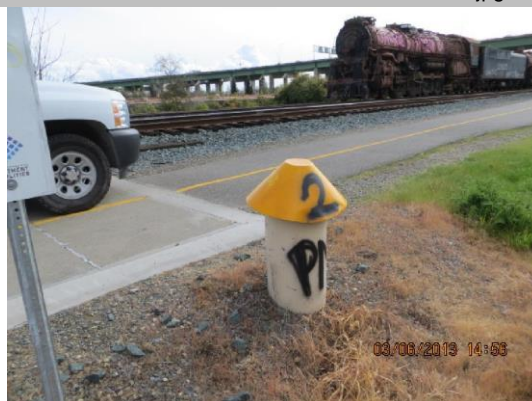
Photo 1 of 3 : UCIP_FA_2018_49958_34051.jpg

View of levee crown--outlet valve structure located along bike path and siphon breaker on waterward shoulder.

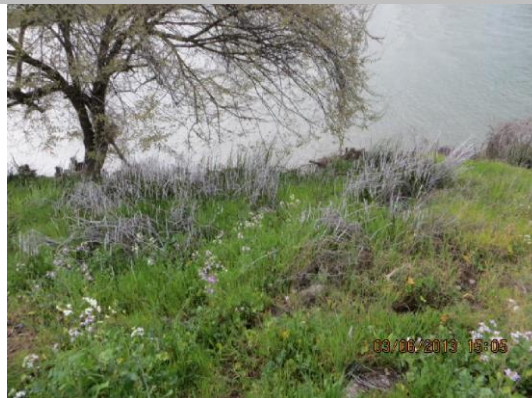
Photo 2 of 3 : UCIP_FA_2018_32883_59501.jpg

View of waterward slope--tall grass limits inspection.

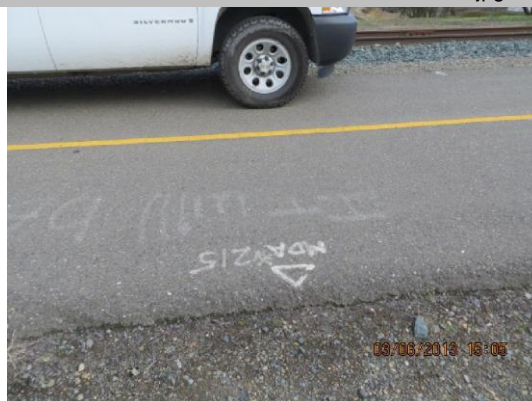
Photo 3 of 3 : UCIP_FA_2018_32883_59500.jpg

View of levee crown (trail) near waterward shoulder edge.

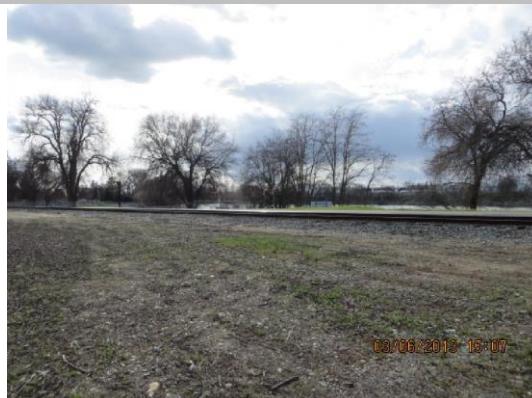
Photo 2 of 3 : UCIP_FA_2018_41442_59559.jpg

View of crossing approximately 110 feet downstream--large sign located on waterward slope.

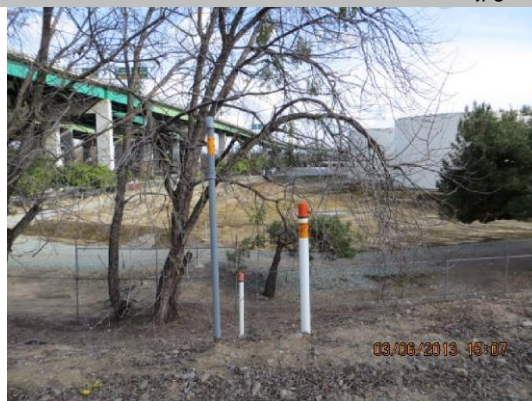
Photo 3 of 3 : UCIP_FA_2018_41442_59558.jpg

View of stand pipes located on landward side.

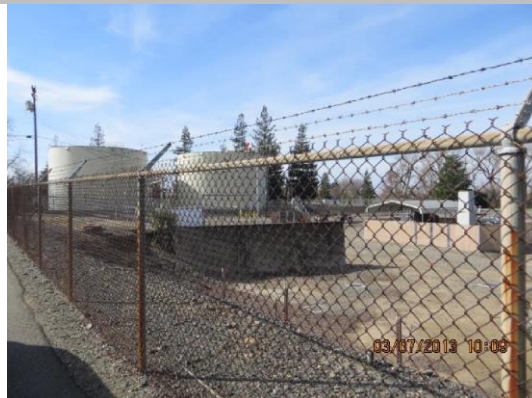
Photo 1 of 1 : UCIP_FA_2018_41444_59572.jpg

Concrete structure still remain in lot on waterward side.

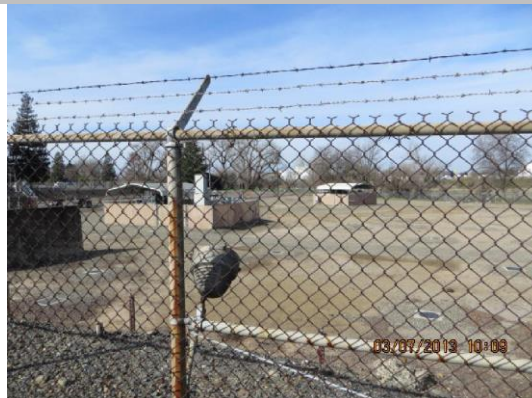
Photo 1 of 3 : UCIP_FA_2018_41282_59575.jpg

Structures present inside lot--site of Ozone Injection and Soil Vapor Extration System for the former Tosco Bulk Fuel.

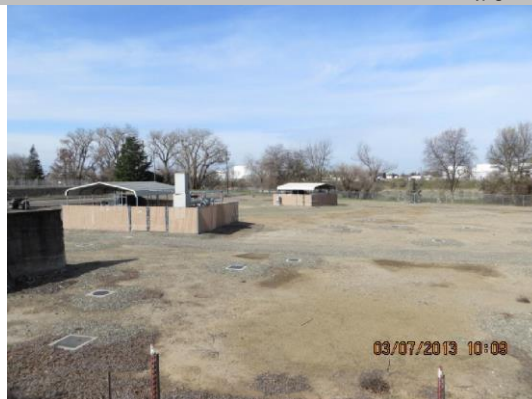
Photo 2 of 3 : UCIP_FA_2018_41282_59574.jpg

Several vapor wells present inside fenced area.

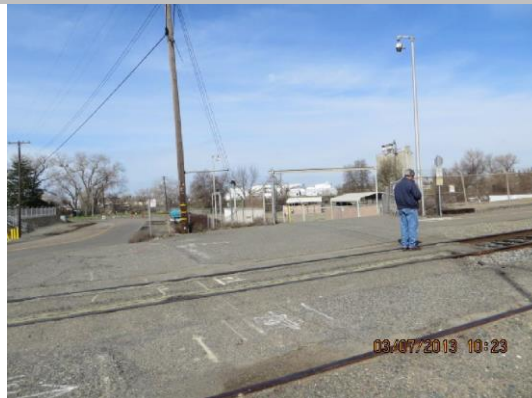
Photo 1 of 3 : UCIP_FA_2018_41427_59507.jpg

View of wide levee crown--old railroad tracks, former Tosco Bulk Fuel Terminal #3493, utility poles, and fire hydrant.

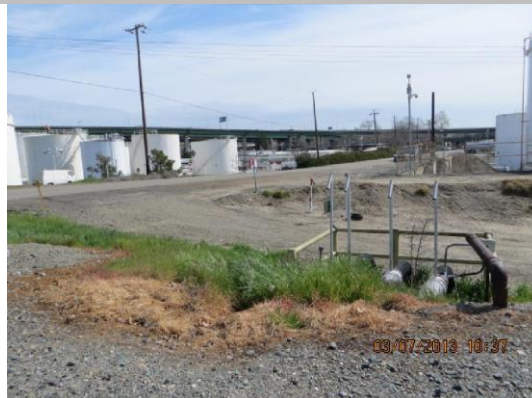
Photo 1 of 3 : UCIP_FA_2018_41452_59525.jpg

View of crossings from levee shoulder.

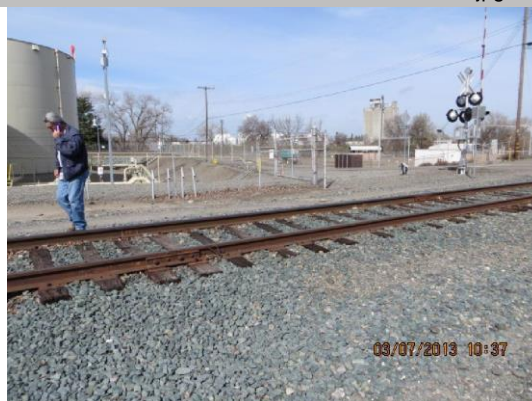
Photo 3 of 3 : UCIP_FA_2018_41452_59523.jpg

Pipe markers visible along chain link fence on waterward side.

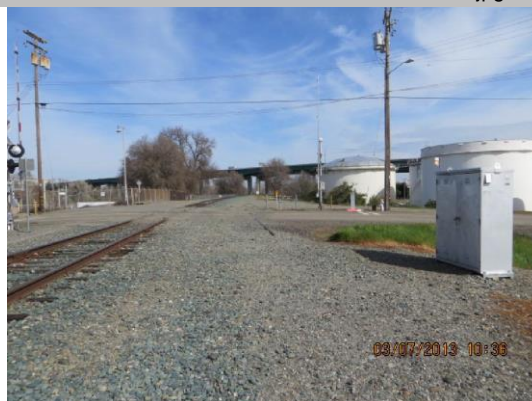
Photo 1 of 3 : UCIP_FA_2018_41448_59511.jpg

View of levee crown looking upstream--rail road traffic signal box located on right side.

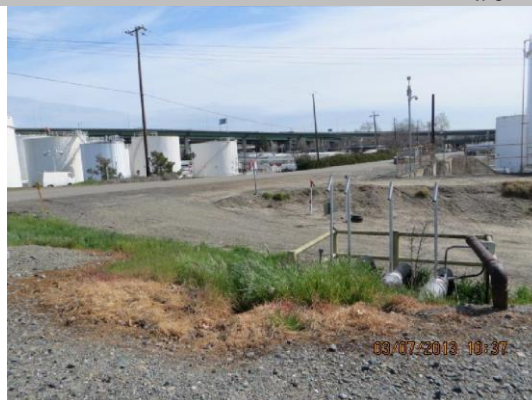
Photo 2 of 3 : UCIP_FA_2018_41448_59510.jpg

Overview of 4-10 inch lines through levee--landward side.

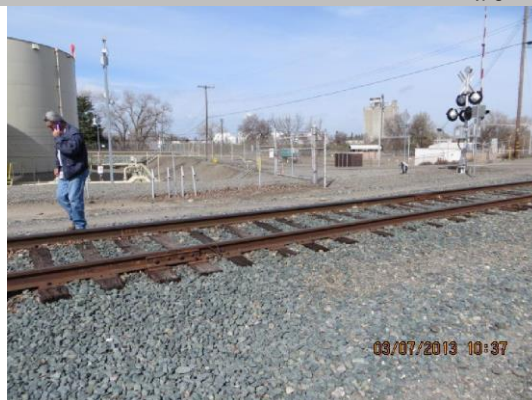
Photo 2 of 3 : UCIP_FA_2018_41449_59517.jpg

View of waterward side--markers visible along chain link fence.

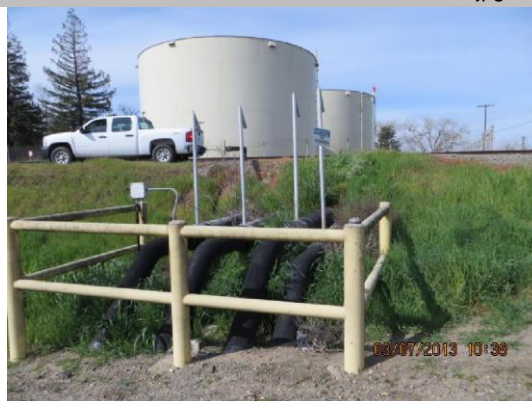
Photo 3 of 3 : UCIP_FA_2018_41449_59516.jpg

Pipes protected by metal post fence--landward side.

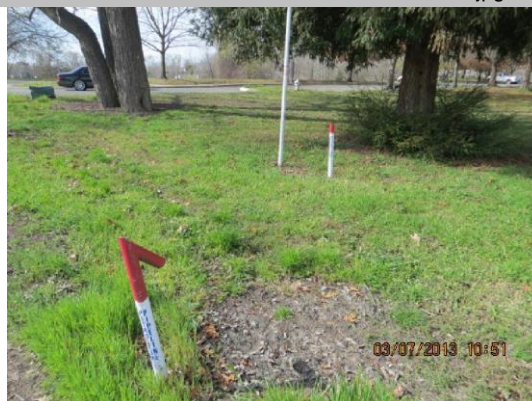
Photo 1 of 3 : UCIP_FA_2018_41457_59529.jpg

View of waterard side--markers visible through levee.

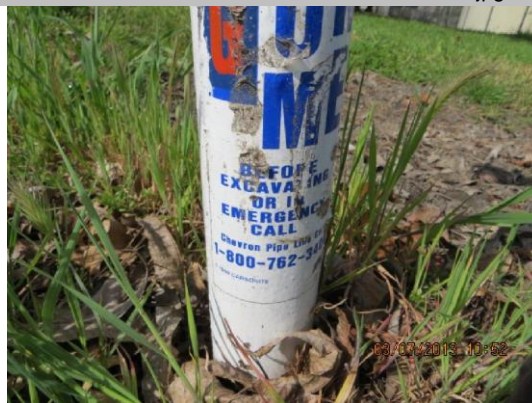
Photo 2 of 3 : UCIP_FA_2018_41457_59528.jpg

Contact information before excavation or in case of emergency.

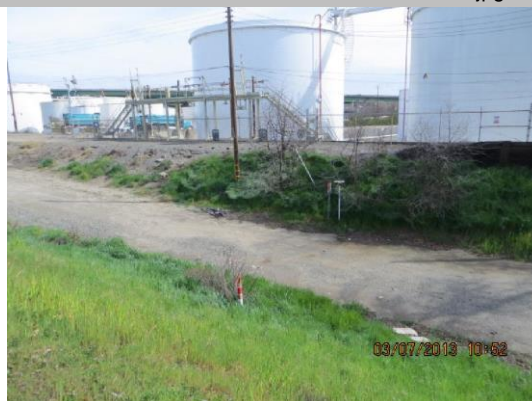
Photo 3 of 3 : UCIP_FA_2018_41457_59527.jpg

Markers visible on landward side.

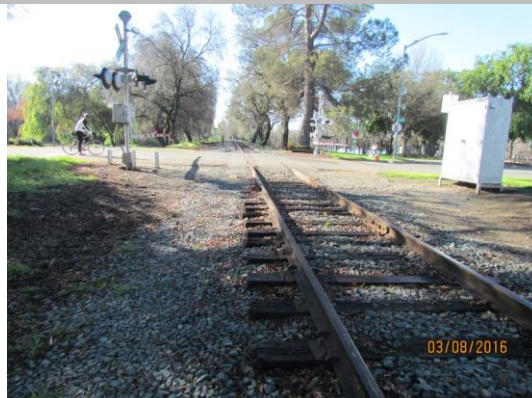
Photo 1 of 3 : FA_2018_NA0005_251_7_20180917_00003.jpg

LM Start	1.95	Rating **	A/W	Issue No.	7
LM End	2.34	Issue Type +	En	Location *	CR
Category	Earthen Levee			GPS Latitude/Longitude	
				Start	End
Item	Encroachments			38.564900 °	38.559460 °
				-121.516253 °	-121.515085 °
DWR ID	DWR_NA0005_01_f_2015_7				
Comment Code					
EQ : Equipment					
Inspector Comment					
Railroad tracks run on crown of levee, paved roadway runs along toe on waterside. This is Miller Park Marina area.

View of the railroad tracks on the crown of the levee looking downstream at levee mile 1.95. Spring 2016.

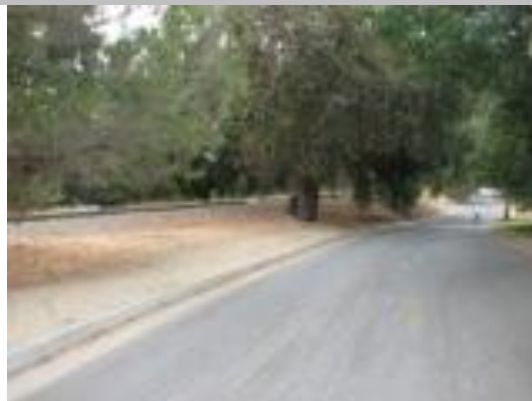
Photo 2 of 3 : FA_2018_NA0005_251_7_20180917_00002.jpg

Railroad tracks are on levee crown. The street is to the boat ramp.

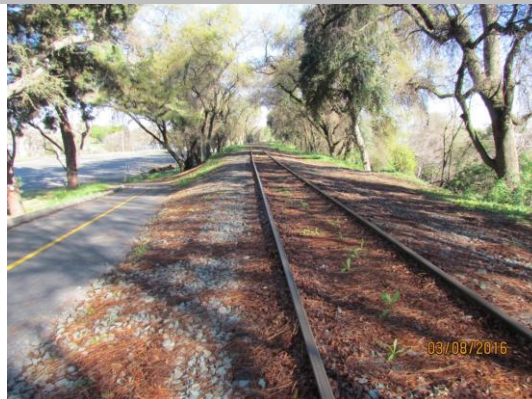
Photo 3 of 3 : FA_2018_NA0005_251_7_20180917_00004.jpg

View of the railroad tracks at levee mile 2.34 on the crown of the levee looking upstream. Spring 2016.

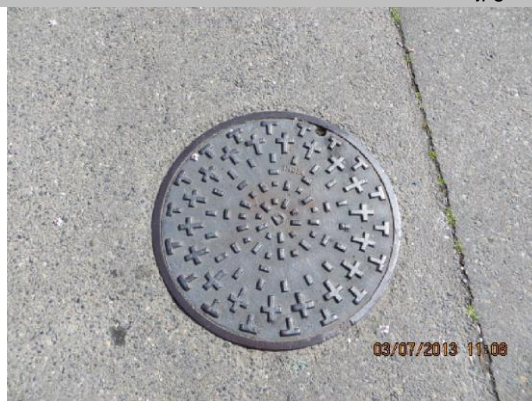
Photo 1 of 3 : UCIP_FA_2018_41430_72757.jpg

Manhole present on roadway.

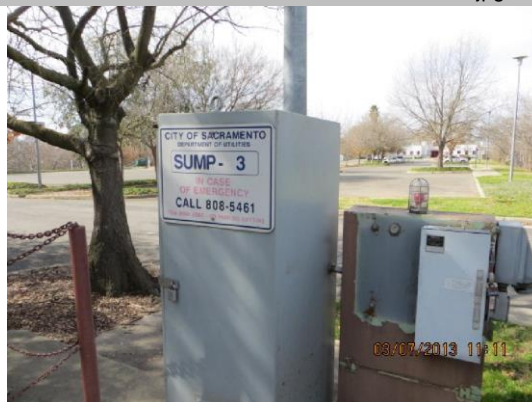
Photo 2 of 3 : UCIP_FA_2018_41430_72756.jpg

Sump pump station 3.

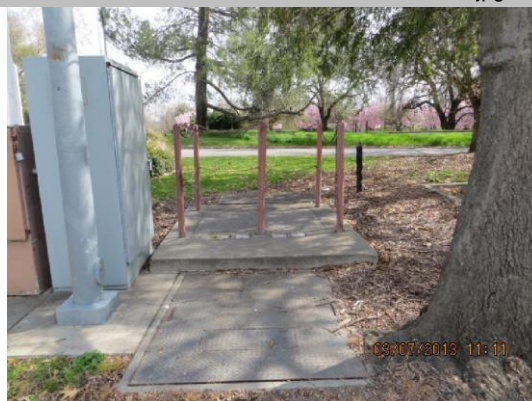
Photo 3 of 3 : UCIP_FA_2018_41430_72755.jpg

Service vault visible on levee crown.

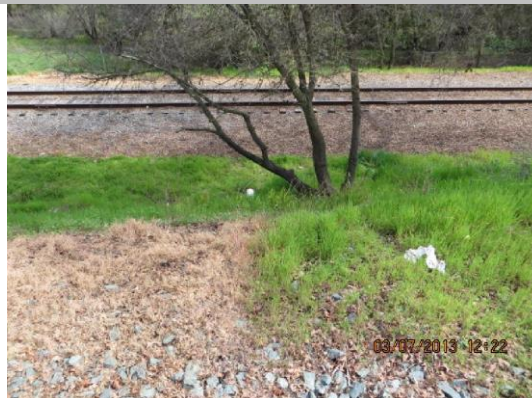
Photo 1 of 2 : UCIP_FA_2018_41293_72760.jpg

Comment Code					
Inspector Comment					
FS_ID:41293					
DS_ID:24921					
EP_NO: N/A					
Repair Type: Non-Urgent					
Crossing Status: Indicator Found					
UCIP Comments: 07/21/2016 Meet with City of Sacramento North Area					
Drainage representatives: Mick Smith and Mike Gonsalves. Pipe					
section along the LS levee removed and the pipe section through the					
levee was grouted. Pipe is linked to PI issue, issue was coordinated					
with the CVFPB. No permit was issued. (DWR UCIP – O. Magana)					
03/06/2013 Need to contact owner to determine type of crossing and					
status. Need to find out the alignment of crossing. (DWR UCIP - O.					
Magana)					
FIELD_STRUCT_DESC: *ABANDONED* 1 of 4. Crossing found					
through railroad/levee visible on landside (LS).					
FS Date: 3/6/2013

PVC pipe through levee.

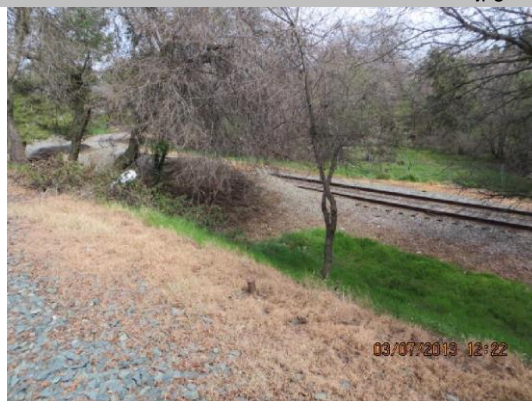
Photo 1 of 2 : UCIP_FA_2018_41295_72764.jpg

Comment Code						
Inspector Comment						
FS_ID:41295						
DS_ID:24923						
EP_NO: N/A						
Repair Type: Non-Urgent						
Crossing Status: Indicator Found						
UCIP Comments: 07/21/2016 Meet with City of Sacramento North Area						
Drainage representatives: Mick Smith and Mike Gonsalves. Pipe						
section along the LS levee removed and the pipe section through the						
levee was grouted. Pipe is linked to PI issue, issue was coordinated						
with the CVFPB. No permit was issued. (DWR UCIP – O. Magana)						
03/06/2013 Need to contact owner to determine type of crossing and						
status. Need to find out the alignment of crossing. (DWR UCIP - O.						
Magana)						
FIELD_STRUCT_DESC: *ABANDONED* 3 of 4. Crossing found						
through railroad/levee visible on landside (LS).						
FS Date: 3/6/2013

LM Start	2.08	Rating **	M	Issue No.	144 (cont)
LM End	2.08	Issue Type +	En	Location *

View of landward side.

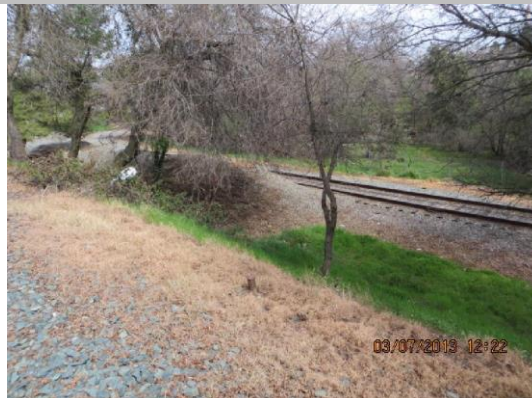
Photo 1 of 2 : UCIP_FA_2018_38827_72766.jpg

Comment Code						
Inspector Comment						
FS_ID:38827						
DS_ID:24924						
EP_NO: N/A						
Repair Type: Non-Urgent						
Crossing Status: Indicator Found						
UCIP Comments: 07/21/2016 Meet with City of Sacramento North Area						
Drainage representatives: Mick Smith and Mike Gonsalves. Pipe						
section along the LS levee removed and the pipe section through the						
levee was grouted. Pipe is linked to PI issue, issue was coordinated						
with the CVFPB. No permit was issued. (DWR UCIP – O. Magana)						
03/06/2013 Need to contact owner to determine type of crossing and						
status. Need to find out the alignment of crossing. (DWR UCIP - O.						
Magana)						
FIELD_STRUCT_DESC: *ABANDONED* 4 of 4. Crossing found						
through railroad/levee visible on landside (LS).						
FS Date: 3/6/2013

LM Start	2.12	Rating **	M	Issue No.	145 (cont)
LM End	2.12	Issue Type +	En	Location *

View of landward side.

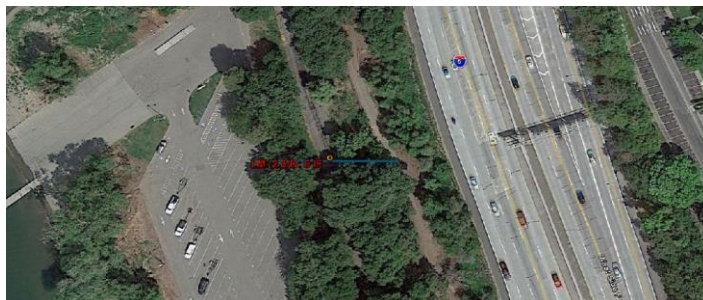
Photo 1 of 1 : UCIP_FA_2018_41431_72800.jpg

Comment Code						
Inspector Comment						
FS_ID:41431 DS_ID:24925 EP_NO: N/A Repair Type: Non-Urgent Crossing Status: Indicator Found UCIP Comments: 07/21/2016 Meet with City of Sacramento North Area Drainage representatives: Mick Smith and Mike Gonsalves. Pipe might be abandoned. No additional information was provided by LMA. (DWR UCIP – O. Magana) 03/06/2013 Need to coordinate with owner to determine status of crossing. (DWR UCIP - O. Magana) FIELD_STRUCT_DESC: 18-inch drainage pipe of unknown material through the levee at an unknown depth below the levee crown. Crossing information was obtained from the City of Sacramento GIS records. FS Date: 3/6/2013

Approximate alignment through levee provided by the City of Sacramento GIS.

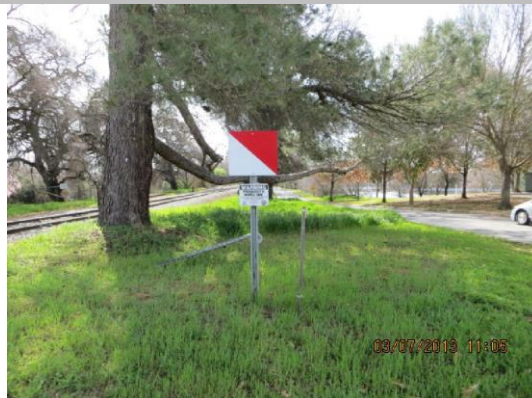
Photo 1 of 1 : UCIP_FA_2018_52602_72758.jpg

FS_ID:52602
DS_ID:24917
EP_NO: N/A
Repair Type: Non-Urgent
Crossing Status: Indicator Found
UCIP Comments: 03/07/2018 Drawings available under Permit No. 4914-C provided approximate levee crossing for dsid 24917, which crosses levee at CLM 2.34, this crossing was previously listed under CLM 1.966. Crossing description, coordinates, and CLM have been updated. Photo from 2013 of paddle marker was taken at CLM 1.966. Need to take photo of paddle marker at CLM 2.34 to update this record. If no marker is present at CLM 2.34, LMA will need to coordinate with owner about adding marker. (DWR UCIP - O. Magana)
07/21/2016 Meet with City of Sacramento North Area Drainage representatives: Mick Smith and Mike Gonsalves. Line goes through crown, goes along WS, and then goes across channel and through West Sacramento Levees (RD0900). (DWR UCIP - O. Magana)
03/06/2013 Need to contact owner to determine additional details--permit, alignment, depth, and last inspection. (DWR UCIP - O. Magana)

FIELD_STRUCT_DESC: 8-inch steel oil product line through the levee, 3.5 feet below the levee crown. (8-inch pipe authorized under Permit No. 4914, -B, 1965 - Standard Oil Company of California, HLM 2.04; 8-inch pipe removed and replaced with new 8-inch pipe (only through RD0900 levee) authorized under Permit No. 4914-C, 2010 - Chevron Pipeline Company) [Additional Reference(s): DWR Levee Log, 2003]
FS Date: 3/6/2013

Marker of gas line visible on levee crown next to railroad tracks.

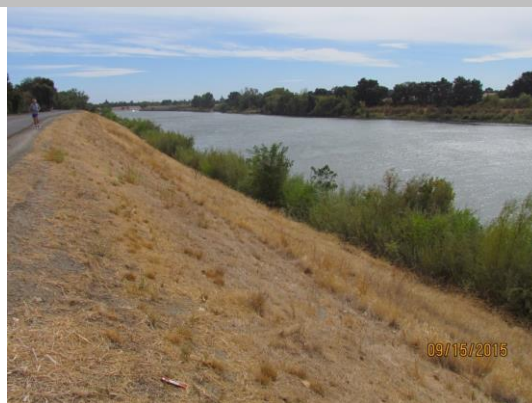
Photo 1 of 2 : FA_2018_NA0005_251_21_20180917_00005.jpg

LM Start	2.46	Rating **	A/W	Issue No.	21
LM End	2.75	Issue Type +	Ob	Location *	WS
Category	Earthen Levee			GPS Latitude/Longitude	
				Start	End
Item	Vegetation			38.557828 °	38.553710 °
				-121.514193 °	-121.512863 °
DWR ID	DWR_NA0005_01_s_2012_21				
Comment Code					
V8 : Environmental Requirements.					
Inspector Comment					
Revegetation site is at the toe of the levee on the waterward side.

View of the revegetation site on the waterward side looking downstream.
Fall 2015.

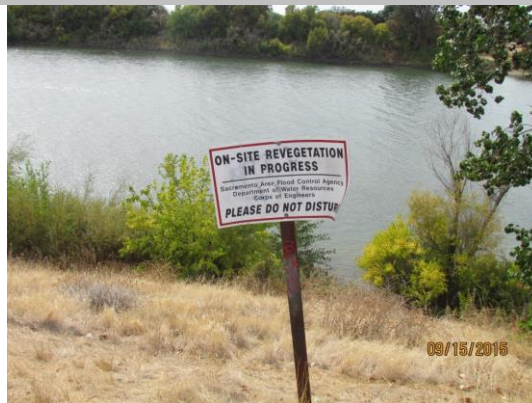
Photo 2 of 2 : FA_2018_NA0005_251_21_20180917_00006.jpg

LM Start	2.46	Rating **	A/W	Issue No.	21 (cont)
LM End	2.75	Issue Type +	Ob	Location *	WS

This area is a revegetation site. Fall 2015.

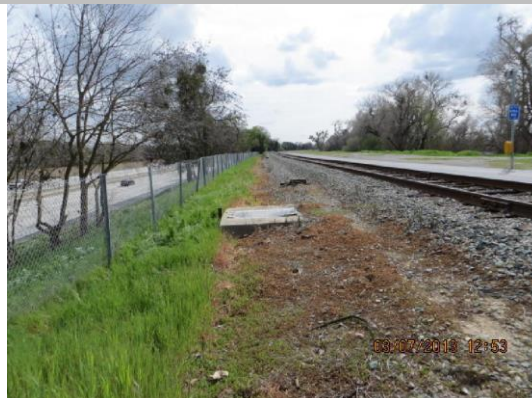
Photo 1 of 3 : UCIP_FA_2018_52603_59534.jpg

Comment Code					
Inspector Comment					
FS_ID:52603 DS_ID:21578 EP_NO: 2043 Repair Type: Non-Urgent Crossing Status: Found UCIP Comments: 07/21/2016 Meet with City of Sacramento North Area Drainage representatives: Mick Smith and Mike Gonsalves. Crossing is not abandoned. The City of Sacramento is currently working at trying to refurbish the Ranney Collector site. According to LMA, pipe is a 30-inch and not a 24-inch pipe. Pipe size and system description updated to reflect LMAs records. This pipe is linked to the USACE's PI issue USACE_CESPK_SACD_2013_a_0211. (DWR UCIP – O. Magana) 03/07/2013 This crossing has been abandoned. According to City of Sacramento Staff the last time this crossing was fired up to see if it was functioning was 3 years ago. Recommend owner coordinating with Central Valley Flood Protection Board (CVFPB) to abandon facility per Title 23. (DWR UCIP - O. Magana) FIELD_STRUCT_DESC: [Ranney Collector] 30-inch discharge pipe through levee at an unknown depth below the levee crown. Collector system located on waterside (WS) slope. (construct one Ranney Water Collector authorized under Permit No. 2043, 1955 - City of Sacramento). [Additional Reference(s): DWR Levee Log, 1993] FS Date: 3/7/2013

LM Start	2.89	Rating **	M	Issue No.	150 (cont)
LM End	2.89	Issue Type +	En	Location *

Concrete vault located on landward shoulder.

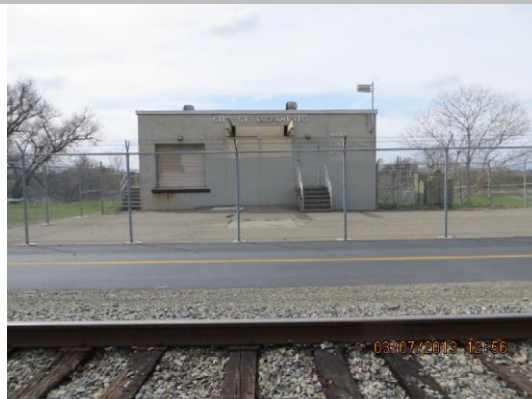
Photo 2 of 3 : UCIP_FA_2018_52603_59532.jpg

Ranney collector facility operated by the City of Sacramento.

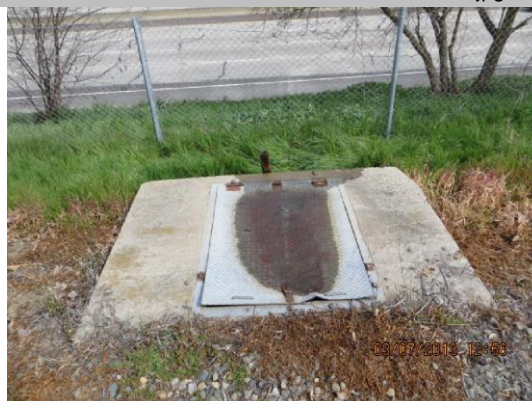
Photo 3 of 3 : UCIP_FA_2018_52603_59531.jpg

Comment Code						
Inspector Comment						
FS_ID:52603 DS_ID:21578 EP_NO: 2043 Repair Type: Non-Urgent Crossing Status: Found UCIP Comments: 07/21/2016 Meet with City of Sacramento North Area Drainage representatives: Mick Smith and Mike Gonsalves. Crossing is not abandoned. The City of Sacramento is currently working at trying to refurbish the Ranney Collector site. According to LMA, pipe is a 30-inch and not a 24-inch pipe. Pipe size and system description updated to reflect LMAs records. This pipe is linked to the USACE's PI issue USACE_CESPK_SACD_2013_a_0211. (DWR UCIP – O. Magana) 03/07/2013 This crossing has been abandoned. According to City of Sacramento Staff the last time this crossing was fired up to see if it was functioning was 3 years ago. Recommend owner coordinating with Central Valley Flood Protection Board (CVFPB) to abandon facility per Title 23. (DWR UCIP - O. Magana) FIELD_STRUCT_DESC: [Ranney Collector] 30-inch discharge pipe through levee at an unknown depth below the levee crown. Collector system located on waterside (WS) slope. (construct one Ranney Water Collector authorized under Permit No. 2043, 1955 - City of Sacramento). [Additional Reference(s): DWR Levee Log, 1993] FS Date: 3/7/2013

Close up view of vault located on landward levee shoulder.

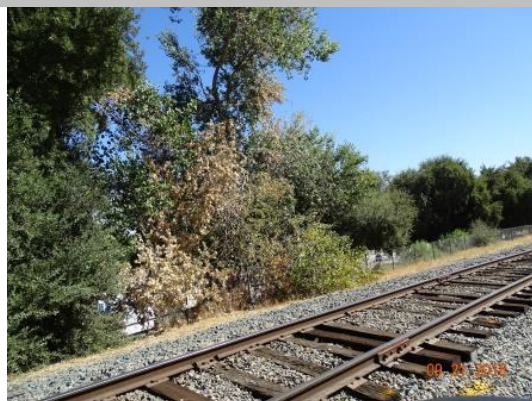
Photo 1 of 1 : FA_2018_NA0005_251_76_20180927_00115.jpg

LM Start	3.17	Rating **	M	Issue No.	76
LM End	3.17	Issue Type +	En	Location *	LS
Category	Earthen Levee			GPS Latitude/Longitude	
				Start	End
Item	Encroachments			38.548027 °	38.548027 °
				-121.510305 °	-121.510305 °
DWR ID	DWR_NA0005_01_f_2018_76				
Comment Code					
TR : Tree or limb					
Inspector Comment					
Caltrans needs to clear fallen tree debris.

Fallen tree debris near fence. Fall 2018
